**AIRPHOTO PATTERNS OF SOILS
OF THE
WESTERN UNITED STATES**

As Applicable to Airport Engineering

Technical Development Report No. 85

August 1948

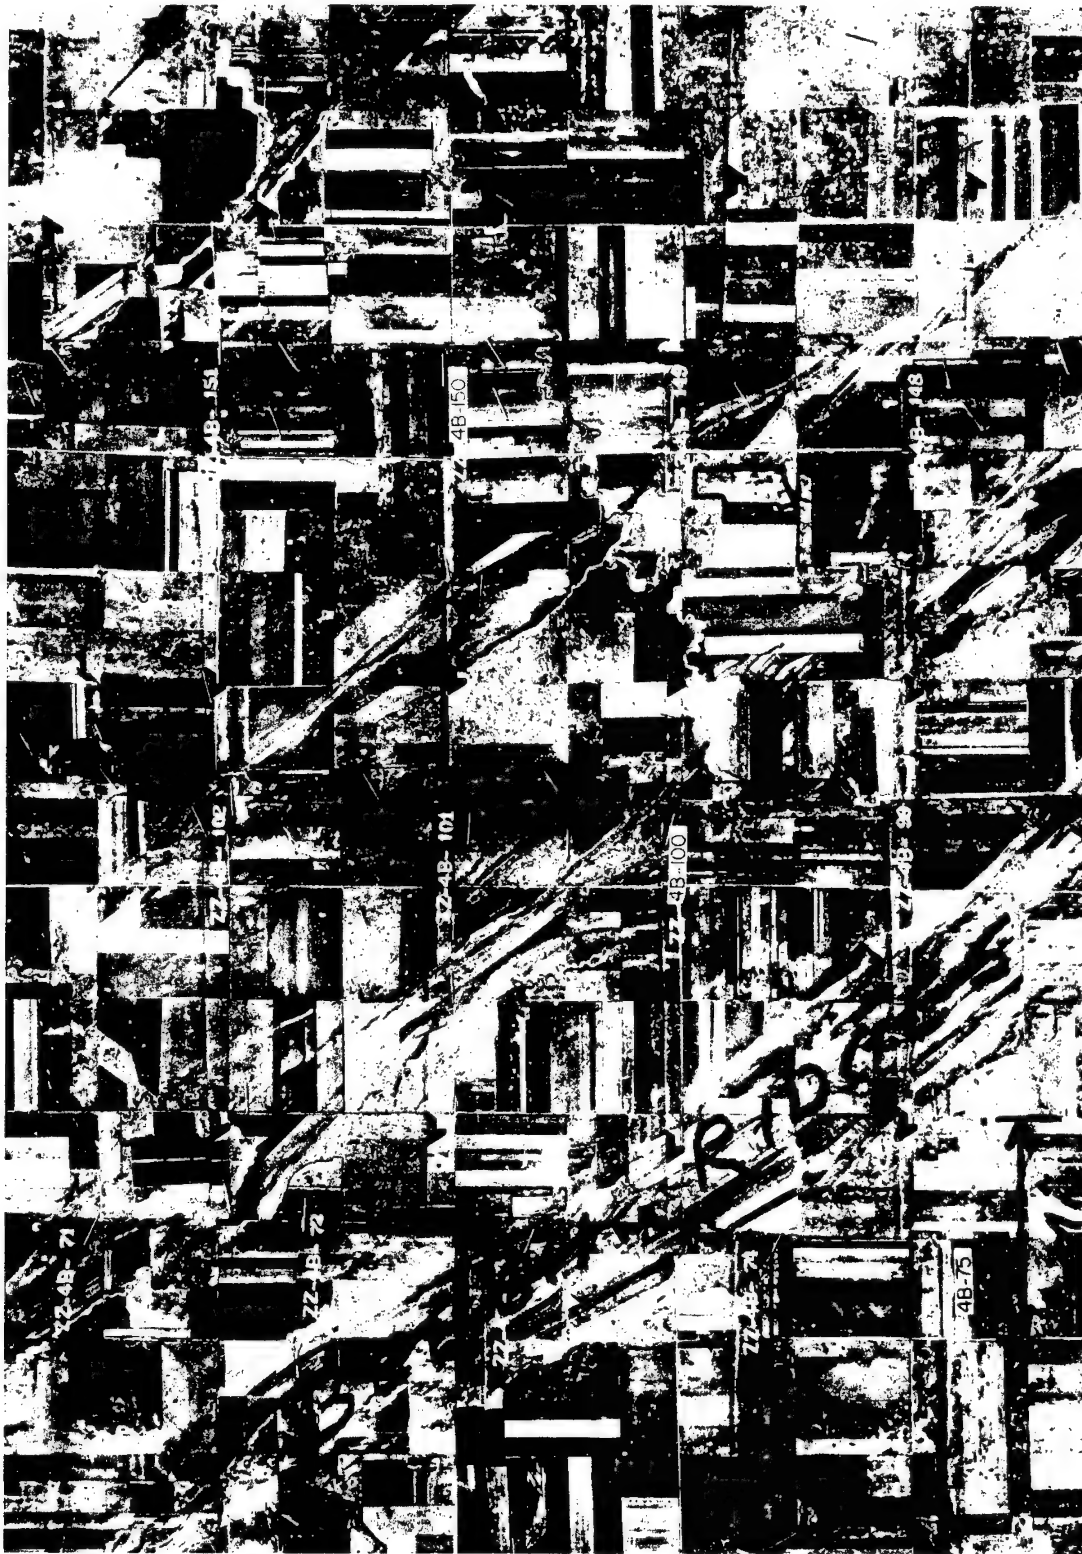
FIGURE 2. *Beach Ridges of Lake Agassiz.* Airphoto mosaic of a series of wave-formed beach ridges (extending from upper left to lower right in the photograph). This pattern is important because it shows granular material in the ridges. Fringing, glacial-lake terraces and beach ridges often are the only sources of granular material in a particular area. Figure 3 is a ground view of a beach ridge in Grand Forks County, N. Dak.

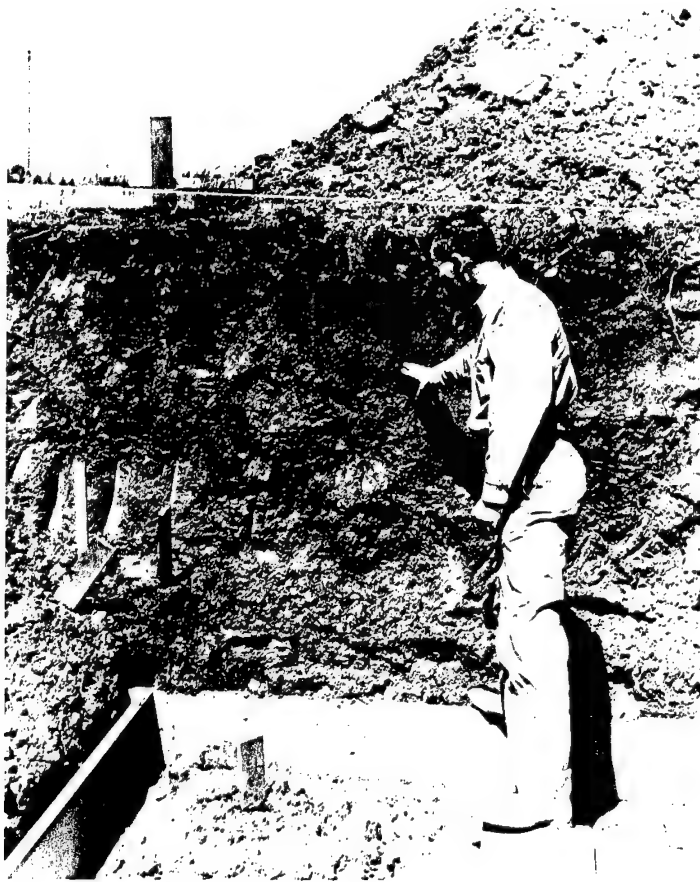
FIGURE 5.—*Lake Agassiz Silt*. This is an exposed profile of deep silt associated with the silt portions of Glacial Lake Agassiz.

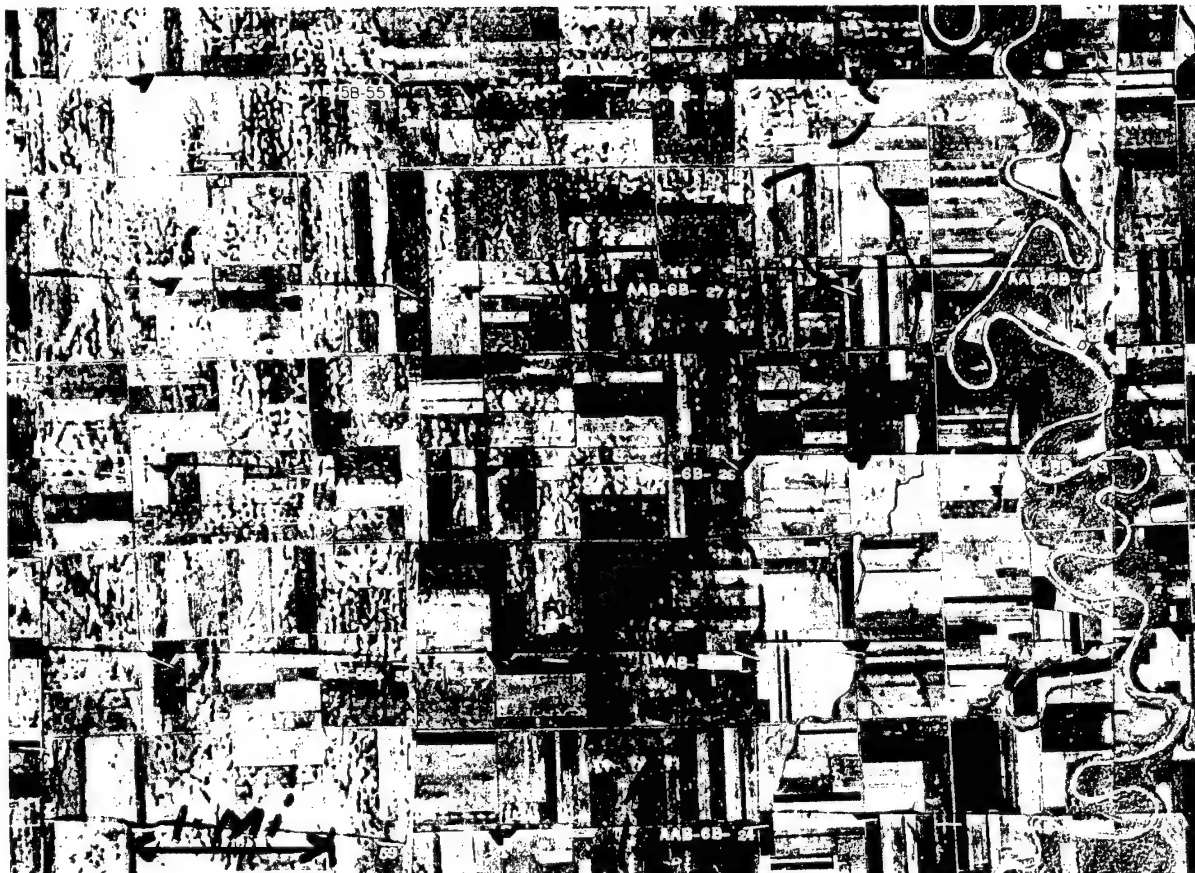
FIGURE 6.—*Plastic Lacustrine Clays (deep organic topsoil)*. The left half of this area exhibits the pattern characteristic of organic lacustrine clays. The organic topsoil is approximately 20 inches deep, and when dry, contains long deep shrinkage cracks. The area adjacent to the Red River (right half) consists of a superficial cover of recently deposited silt consisting of a broad, low natural levee that has been built up in recent times. This is indicated by the obliteration of the original-clay pattern by silt as shown on the left side of the photo. The gullies draining into the river are confined to the silt cover, the character of which shows the presence of a porous, fine-grained material on an impervious clay. The light-colored area adjacent to the river also illustrates this levee formation. The absence of sand bars at the bends in the stream indicates the fine texture of the material being carried in this aggrading stream. The absence of heavy vegetation shows the climatic influence in this area. Note the reversal of color of the streaks of this pattern (black is clay; white is alkali influence) as compared to the streaks of figure 4 (white streaks are silt). Figure 7 illustrates the topography of this flat lakebed area.

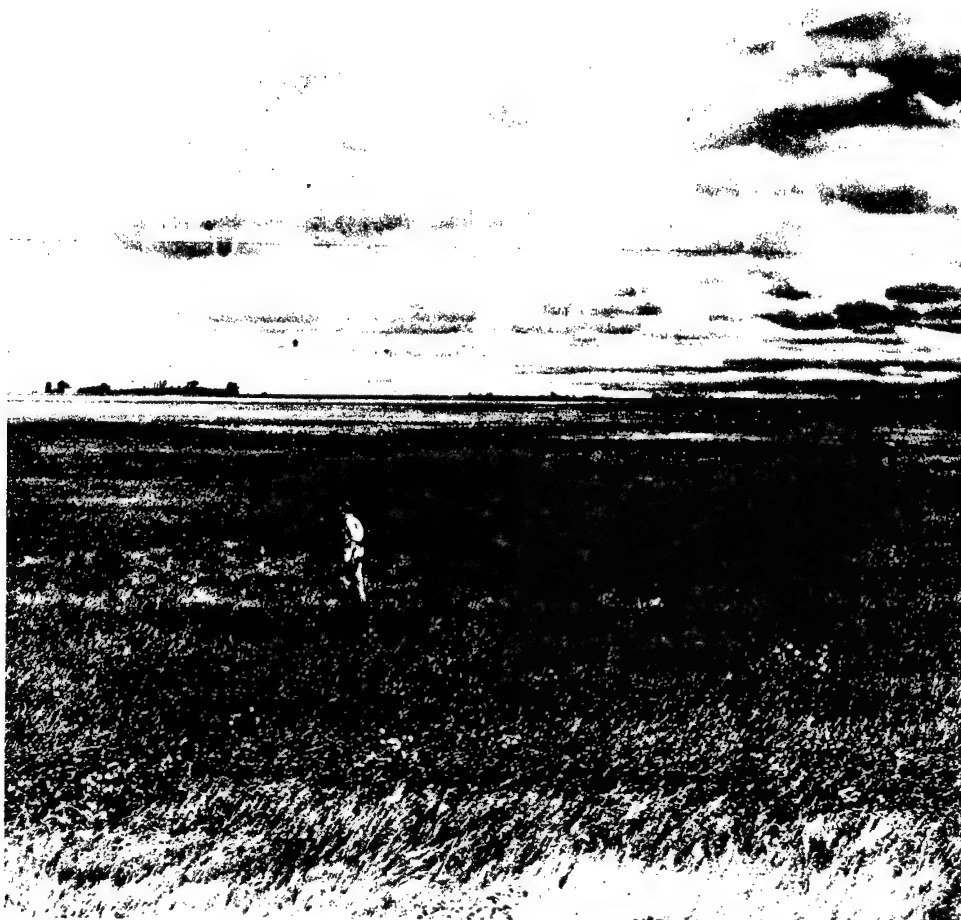
FIGURE 7.-- *Alkali Depression.* Note the vegetative change associated with this alkali spot. (The man is in the center of the alkali depression.) Such depressions occur in plastic clays of lakebed regions where evaporation is higher than precipitation. Alkali spots can be detected in airphotos by the change in vegetation and general light color tone. Note the flat topography and the absence of trees (Fargo, N. Dak.).

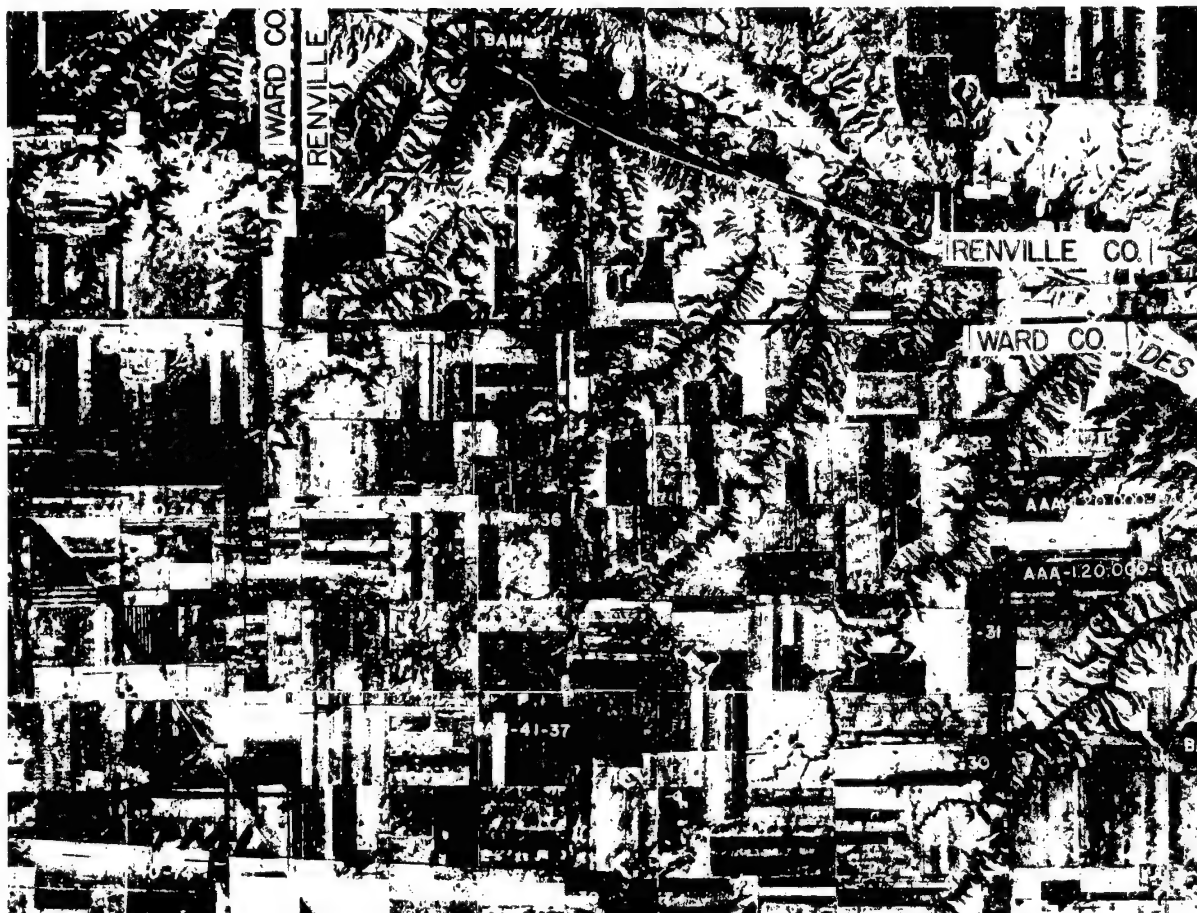
FIGURE 8.—*Glacial Lake Souris*. This mosaic is typical of the airphoto pattern of the Souris and Des Lacs River Valley which drains glacial Lake Souris. This stream has cut a broad channel or valley in the lakebed (fig. 9). These streams are degrading while the Red River is aggrading. The stream marks the boundary between the lakebed proper and the southern shore which fact is clearly indicated by the numerous gullies (coulees) flowing northward into the river and the absence of south-flowing gullies. Granular material occurs frequently as terraces in the stream valley and at isolated spots along the valley walls, all at levels below the lakebed proper.

The location of gullies with respect to main and tributary drainage channels is important in analyzing the soil textures of lakebeds. Comparison of the drainage pattern of Lake Souris with that of Agassiz shows the importance of this feature. The Souris River in western North Dakota has cut a deep channel in the lakebed and is a degrading stream, while the Red River (Lake Agassiz) is building a natural levee in the lakebed and has not cut a deep channel.

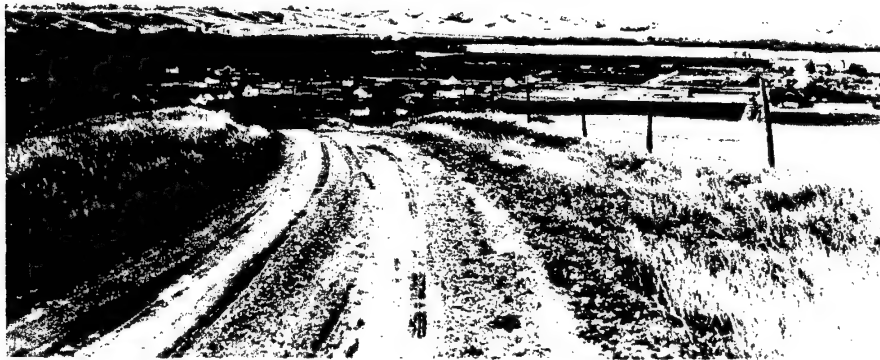
FIGURE 9.—*Souris River Valley at Minot.* Ground view of the deep river valley carved in the bed of glacial Lake Souris. Note the level horizon line across the valley; this is the lakebed proper. Also note that the heavy vegetative cover is confined to the valley floor.

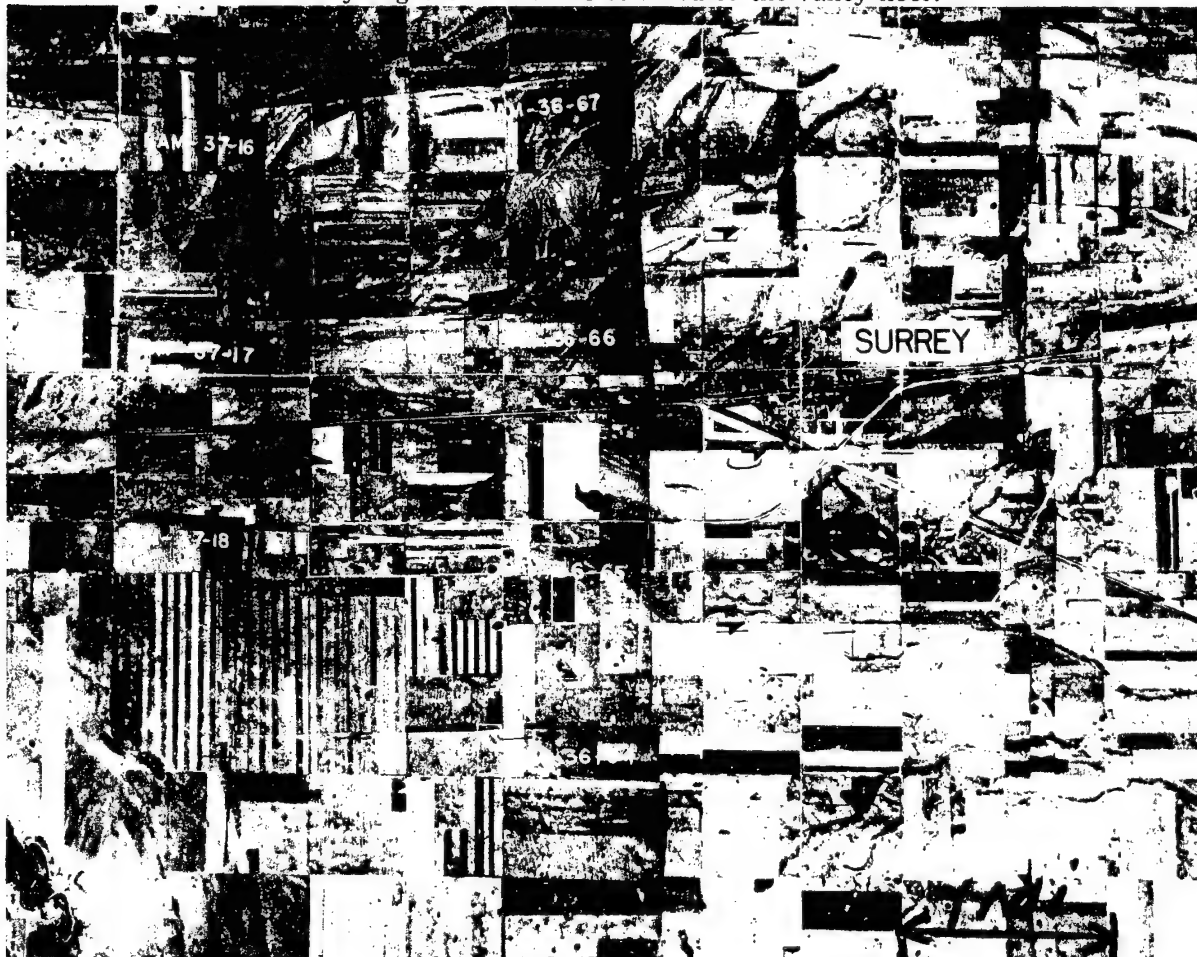
FIGURE 10.—*Current and Channel Scars in Lake Souris.* The numerous channel scars occurring in this area illustrate the intense glacial activity in this former lake. Such vigorous current action is usually accompanied by deposition of large amounts of granular material. The surface of the lakebed in this region contains granular deposits. Detailed examination of stereo-matched photos makes it possible to locate such deposits.

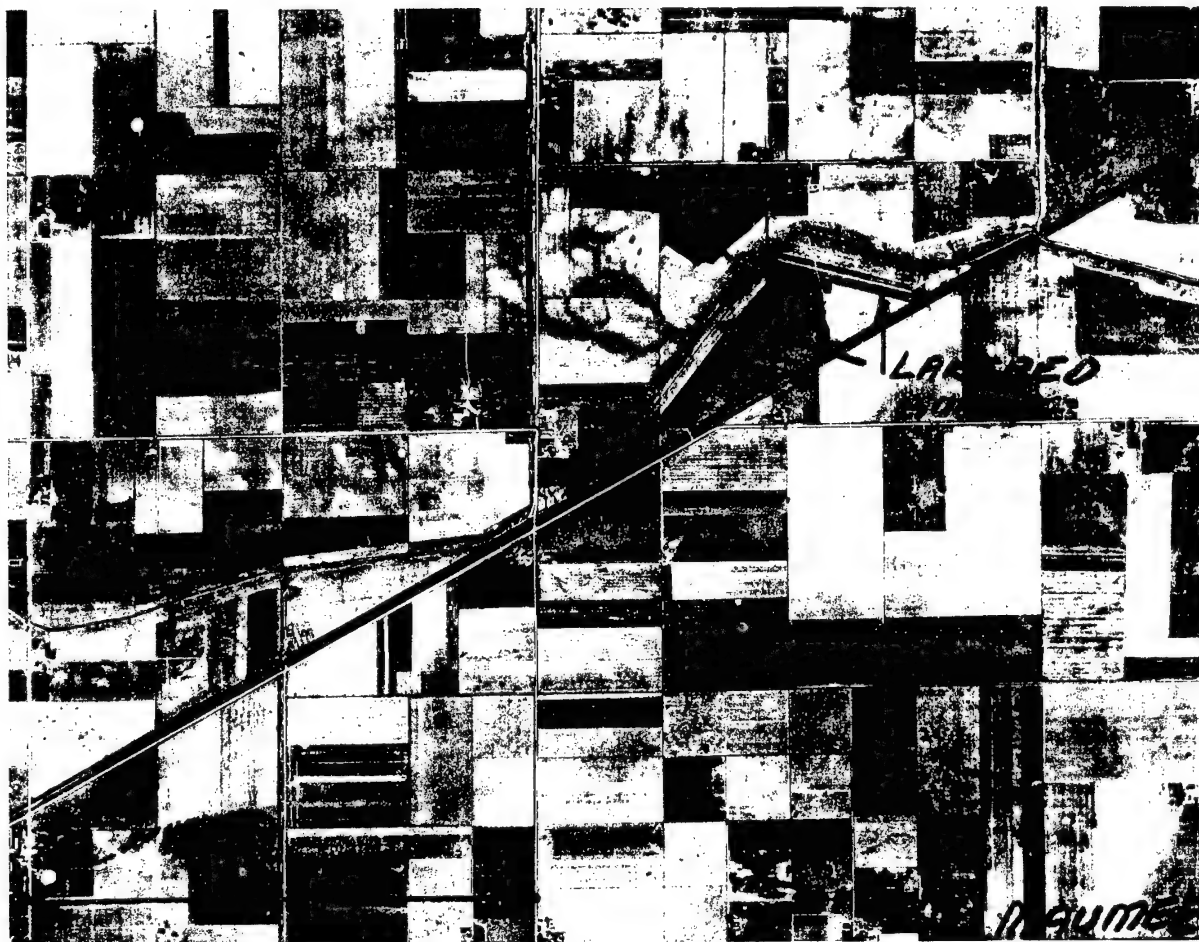
FIGURE 12.—*Glacial Lake Maumee.* This photo shows the airphoto pattern typical of glacial Lake Maumee which is that of deep lacustrine clay and silty clay. The dark areas are slightly depressed, contain greater quantities of organic material, and have a high ground-water table. Note the gully; gullies of this type are definite indicators of lacustrine soils. The topography is flat, such as that of Agassiz and the portion of Souris not yet reduced by erosion. The topsoil is organic and of varying depth, depending on the topographic position. The subsoils consist chiefly of plastic clays and silty clays. Glacial Lake Maumee also contains a series of fringing granular beach ridges, some of which serve as locations for major United States highways.

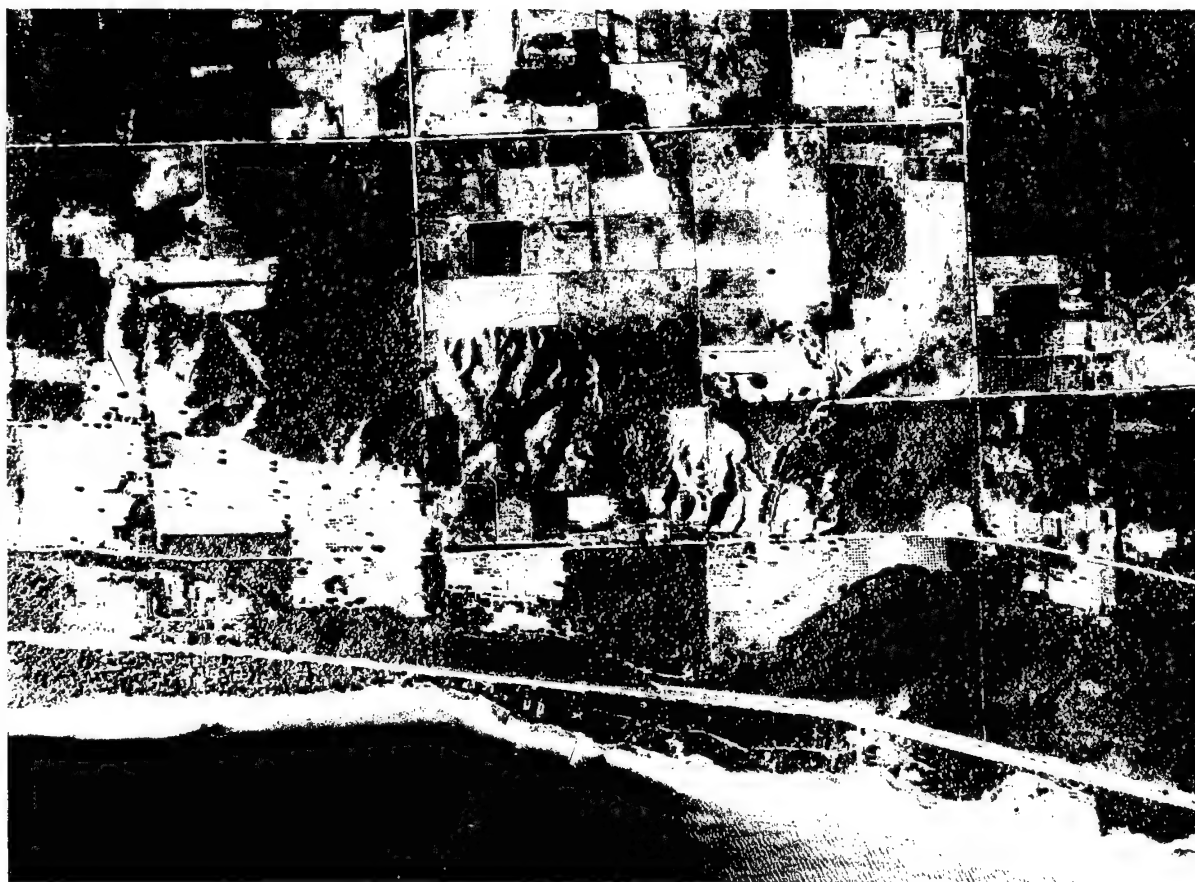
FIGURE 15.—*Glacial Lake Beaches.* This northern Michigan airphoto shows the pattern of two distinct glacial lake beaches now occupying the topographic position of terraces. Note the erosional features accompanying each change in slope. The beaches in this instance are granular. See figure 16 for a ground view of a similar situation occurring near Duluth, Minn.

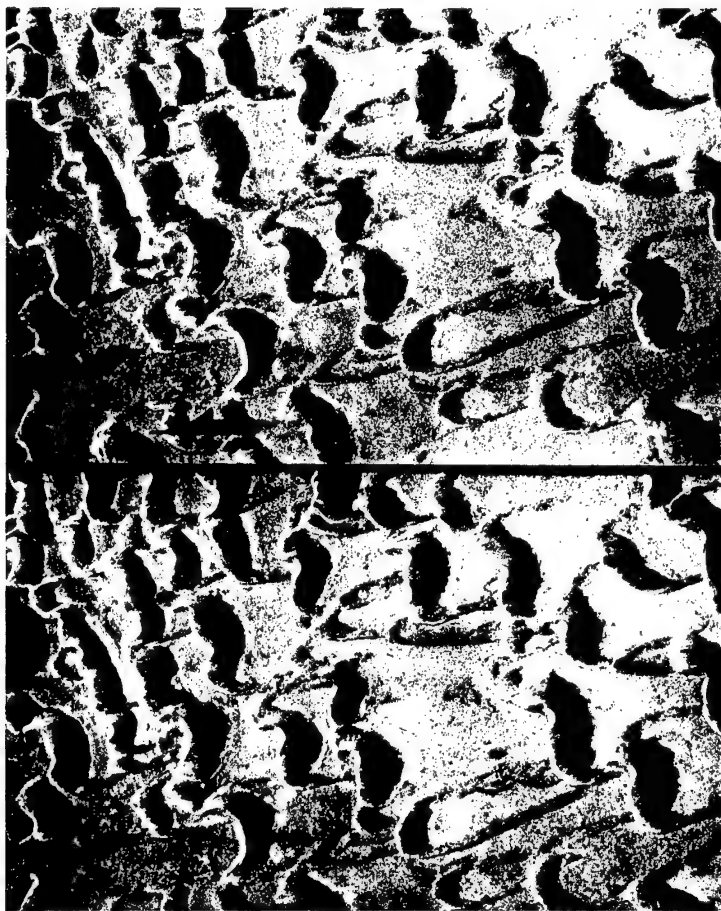
FIGURE 17.—*Barchane Dunes*. A stereopair showing volcanic sand in the form of dunes in central Washington—another variation in the sand dune pattern. This is a region of low rainfall.

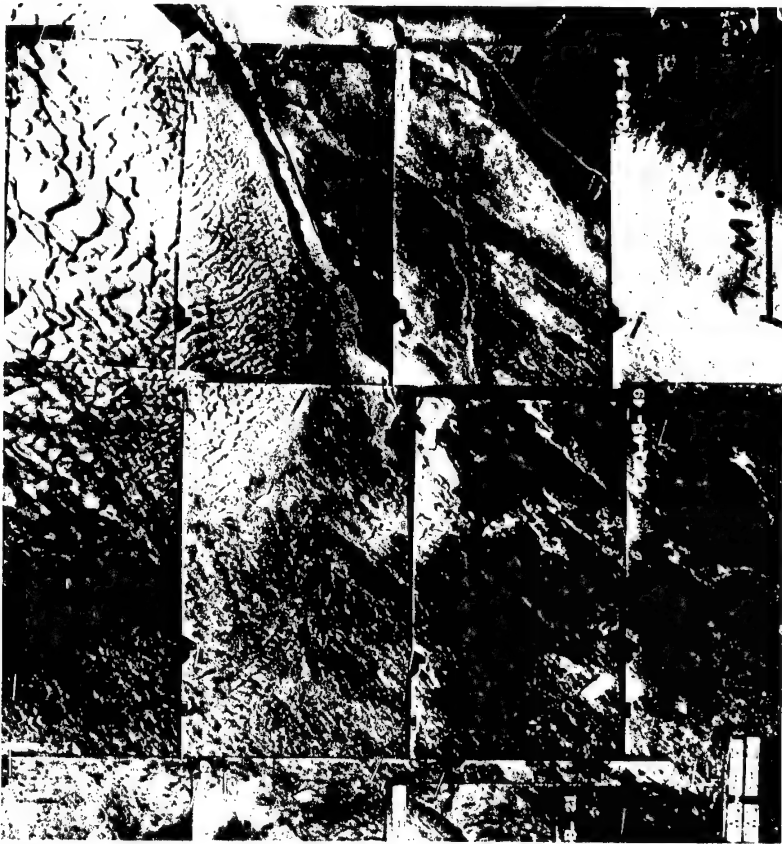
FIGURE 21.—Rippling Dune Pattern Occurring in Colorado.
Note the directional trend in the streaks below the dune pattern.
The entire area has a wind-swept appearance.

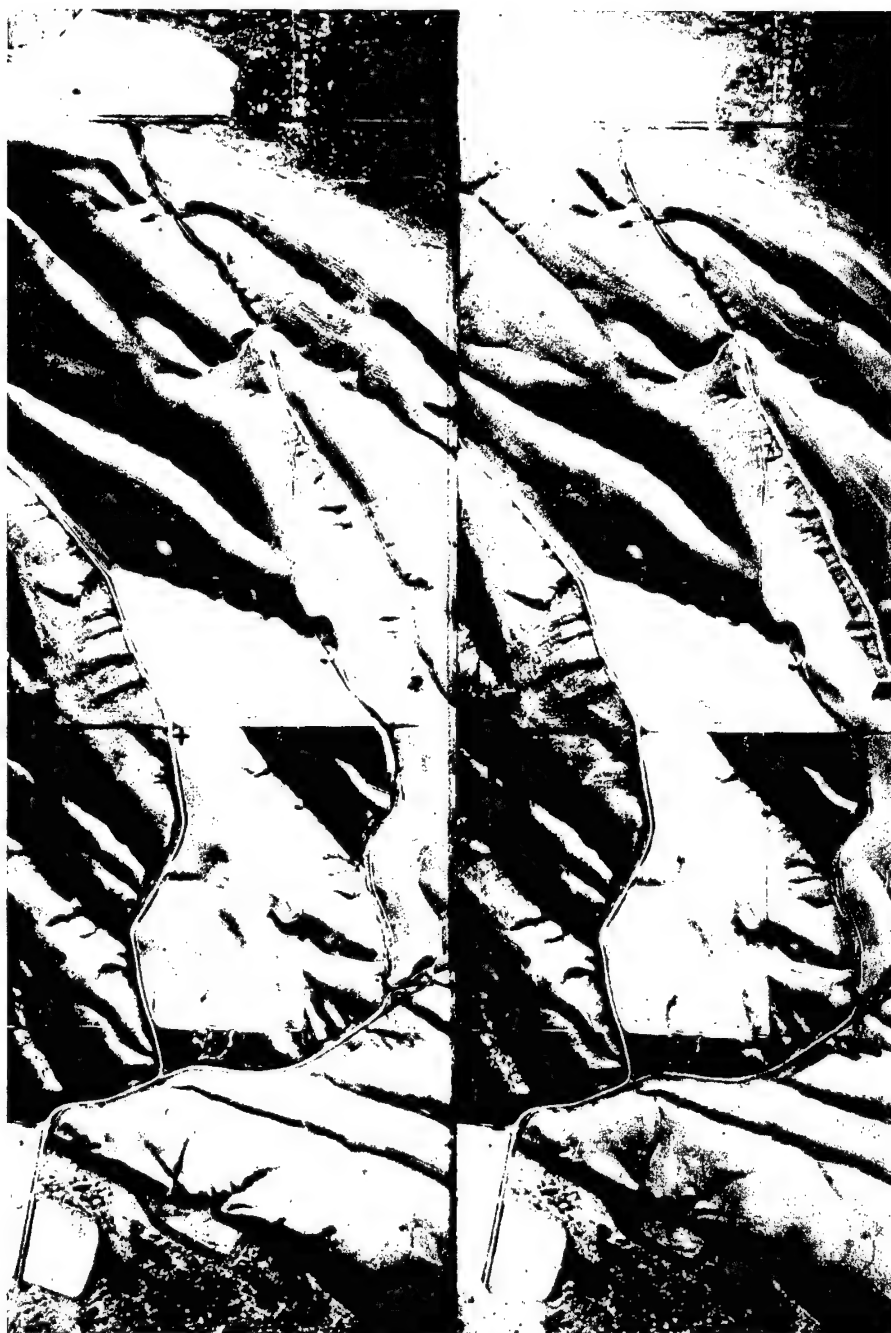
FIGURE 26. *Stereopair of One Type of Palouse Loess, Showing Land Form, Drainage Pattern, Gully Systems, and Land Use Typical of the Rolling Palouse Areas (Adams County, Wash.).* Note that the land form is quite rolling yet the hills are very softly rounded never angular. The drainage of the area consists of a system of parallel gullies, the laterals of which are short and enter at right angles, thereby creating the "fishbone," or pinnate, drainage pattern. Such elements as "cat steps" and pinnacles are not contained in this view because gully erosion has been checked by proper agricultural practices.

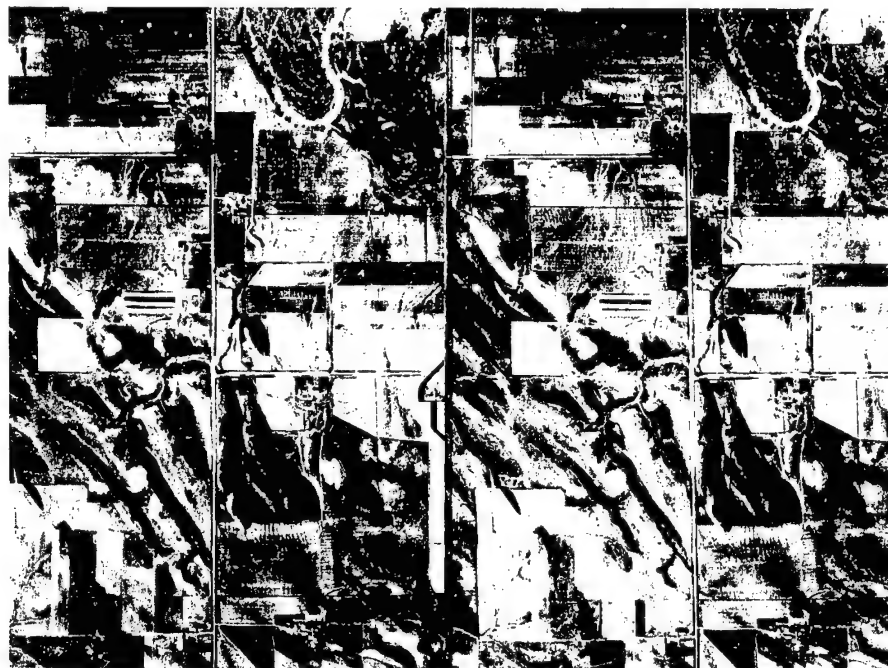
FIGURE 30.—*Loess of the Rolling Areas of the Great Plains*. Stereopair showing the land form of the more rolling areas of the Great Plains loess regions and the strong parallelism of the hills and drainage systems (Madison County, Nebr.).

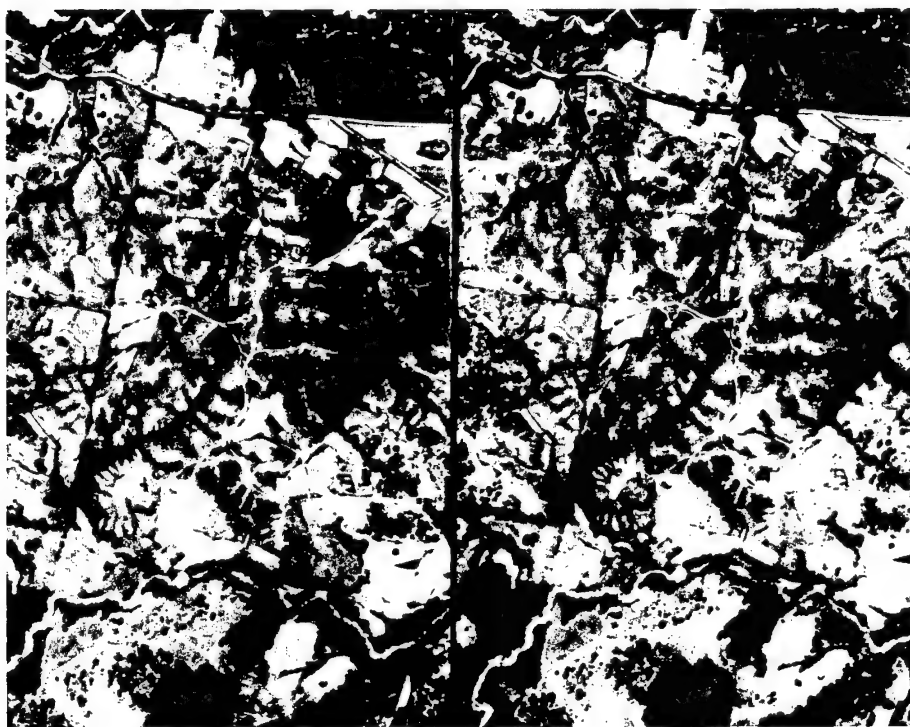
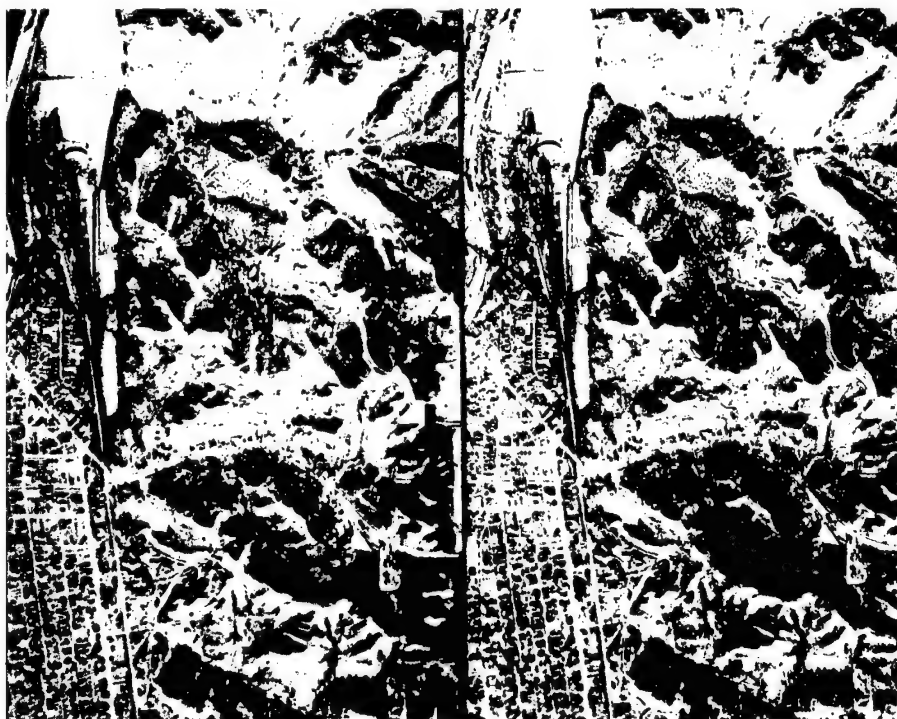
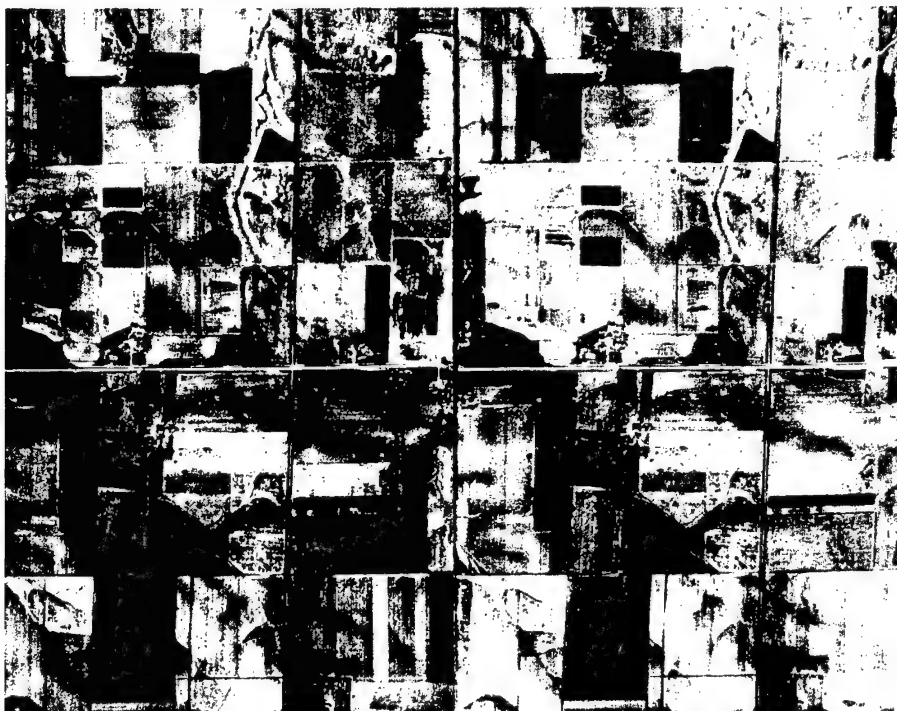
FIGURE 31. *Land Form Typical of the Upper Mississippi River Loess
(Jo Daviess County, Ill.).*

FIGURE 32. *Land Form of the Lower Mississippi River Valley Loess
Area (Adams County, Miss.).*

FIGURE 33. --*Rugged Loess Topography Adjacent to the Missouri River in Woodbury County, Iowa.*

FIGURE 34. --*Rolling Land Form in the Missouri Valley Some Distance from the River. Note the existing parallelism in hills and drainage systems (Plymouth County, Iowa).*

The land form of the loess along the Mississippi Valley is illustrated in figures 31 to 34. Figures 31 and 32 show the patterns typical of the upper and lower Mississippi River areas as found in Jo Daviess County, Ill., and Adams County, Miss., respectively. The loess patterns along the Missouri River, shown in figures 33 and 34, are in Woodbury and Plymouth Counties, Iowa.

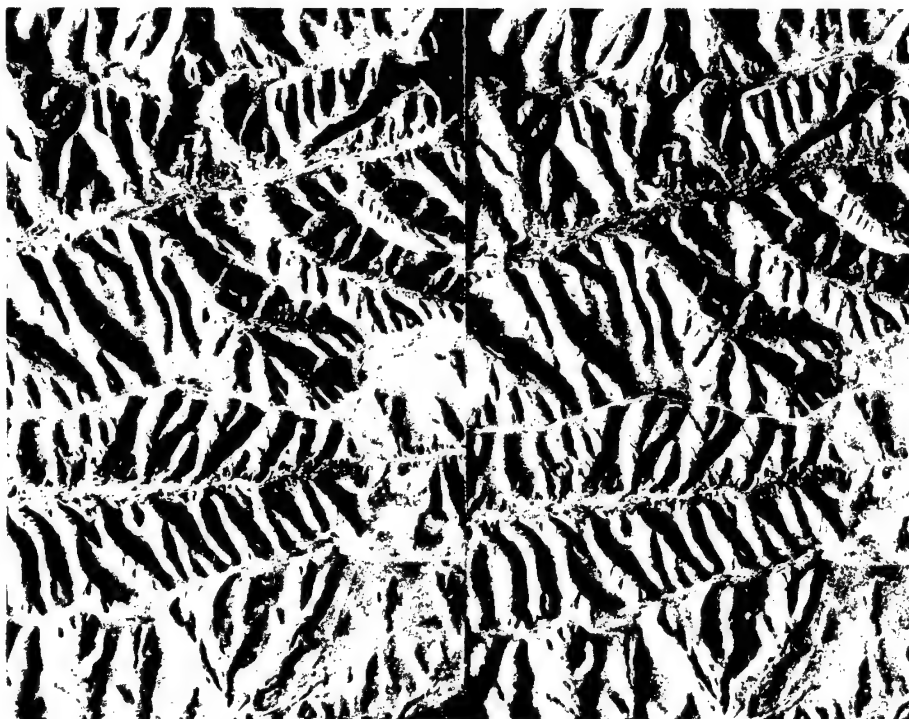
FIGURE 36. --*Loessial Erosion*. Stereopair showing silt pinnacles and the fishbone (pinnate) drainage system. The pinnacles occur as isolated columns in the bottom of gullies or as fins or ribs on gully sides.

terrain, they may extend for miles in a nearly straight line. The main gully channels have short, steep, gully laterals that enter at right angles and create the fish bone appearance illustrated in figures 35, 36, and 37. This is the pinnate-type drainage pattern. In arid and semiarid regions the gullies and channels are often dry and support a sparse vegetation, while in humid and subhumid regions they are filled with heavy vegetation. The over-all drainage and gully systems of the more rolling areas also exhibit a parallelism that appears to be associated with the parallelism of the hills.

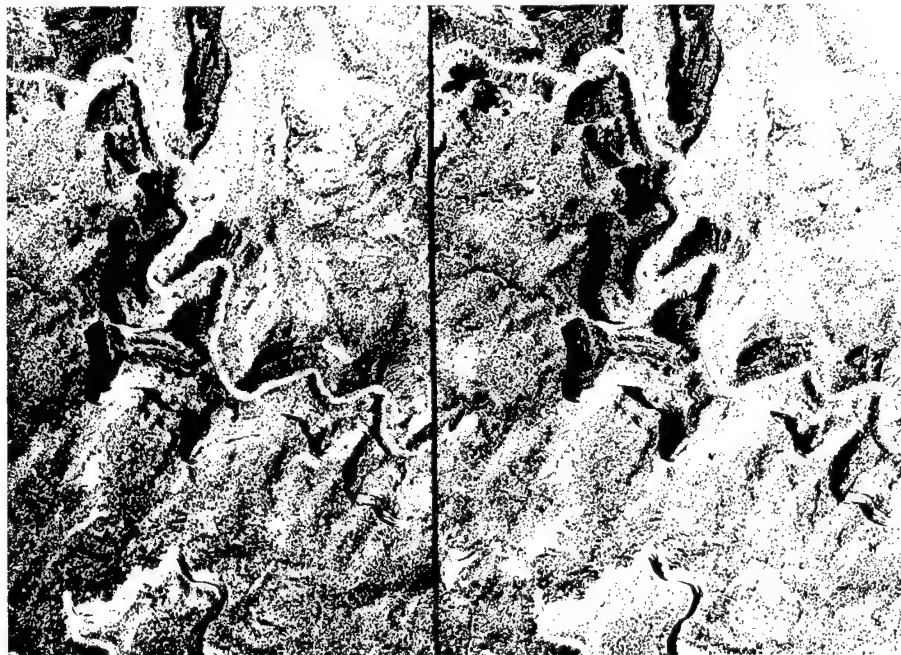
FIGURE 40. *Massive Sandstone*. This shows the blocky land form produced by weathering of thick beds of flat-lying sandstone in an arid region. The outstanding features of this pattern are the deep canyons, intermediate plateaus, and high mesas (Mesa County, Colo.).

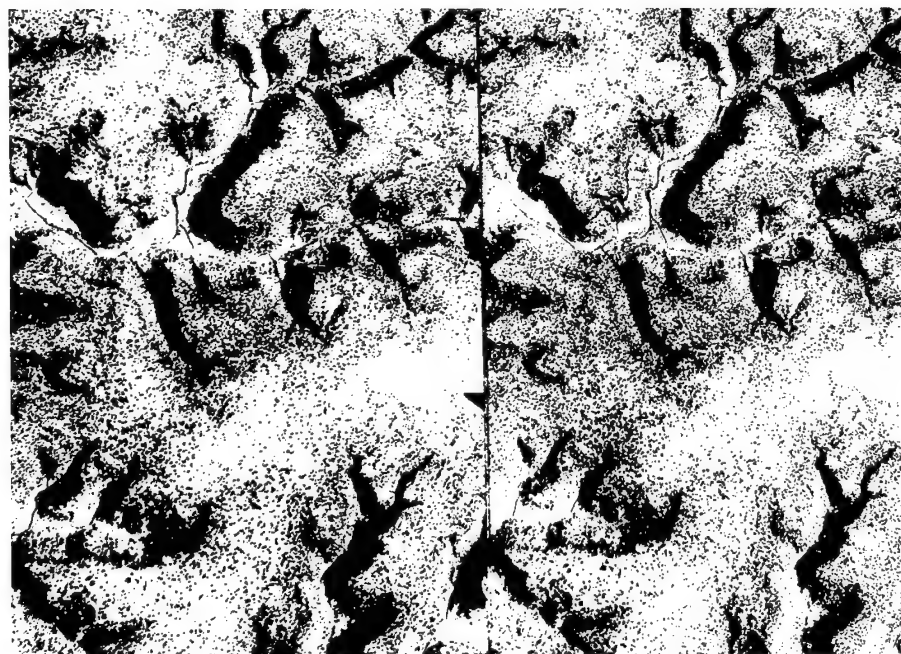
FIGURE 41. *Thick Sandstone on Shale*. This shows nearly horizontal-lying strata of sandstone on clay shale. Note that the sandstone layers (inter-drainage divides) produce vertical slopes and that the clay shale layers weather to produce soft slopes (Otero County, Colo.).

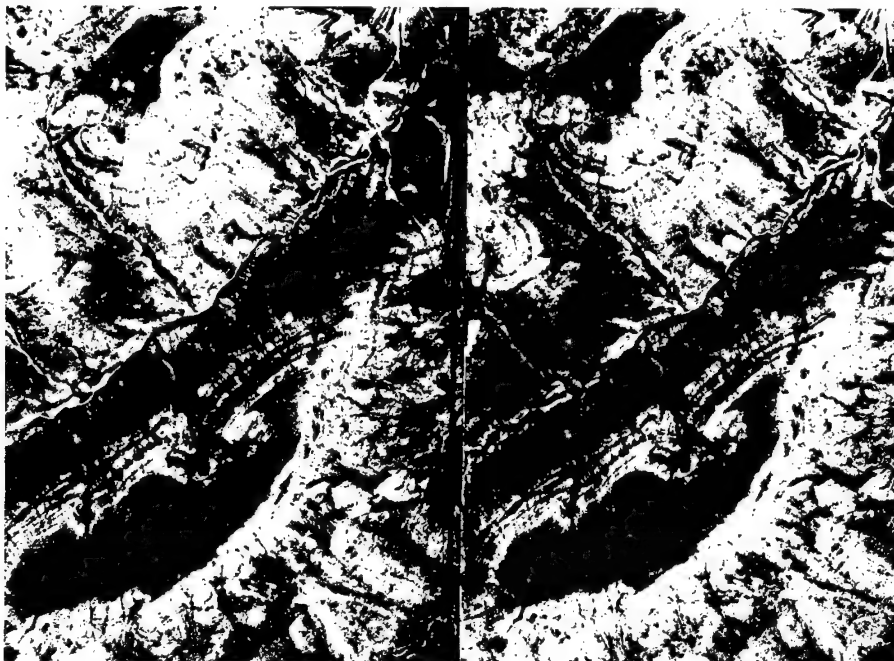
FIGURE 42.—*Badlands Formed in Nearly Horizontal Beds of Variegated Clay and Sandy Shales (10 to 15 inches of rainfall). Note the flat-topped portion which is a remnant of the once level plain. The softly rounded gully slopes and erosional scars are characteristic of the clay shales. The over-all drainage pattern of this area is dendritic (Sheridan County, Wyo.).*

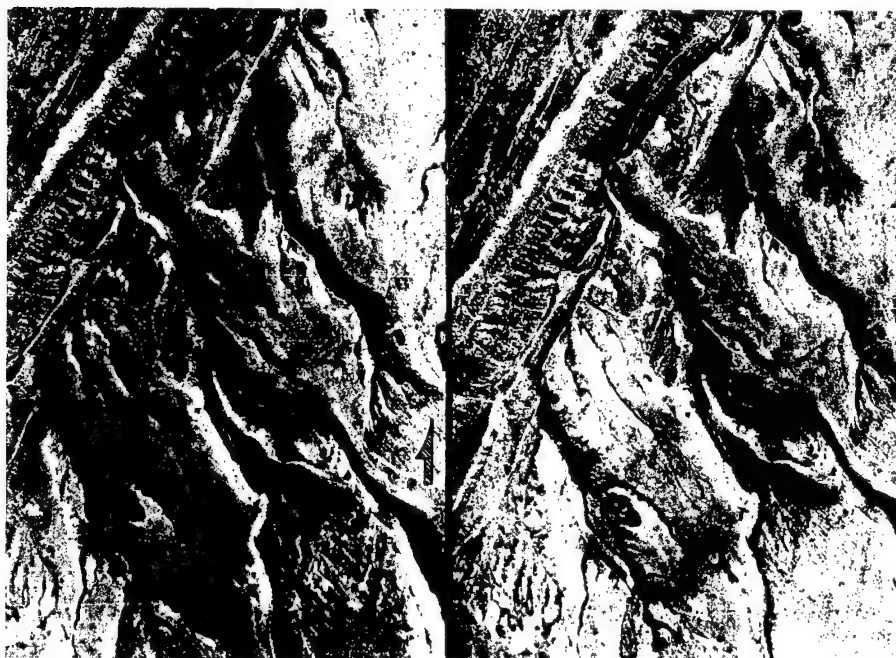
FIGURE 43.—*Tilted Sandstone and Shale. This shows tilted, thick shale capped with alternating layers of thinly bedded sandstone and shale (15 to 20 inches of rainfall). The drainage pattern is trellis-like (Fremont County, Wyo.).*

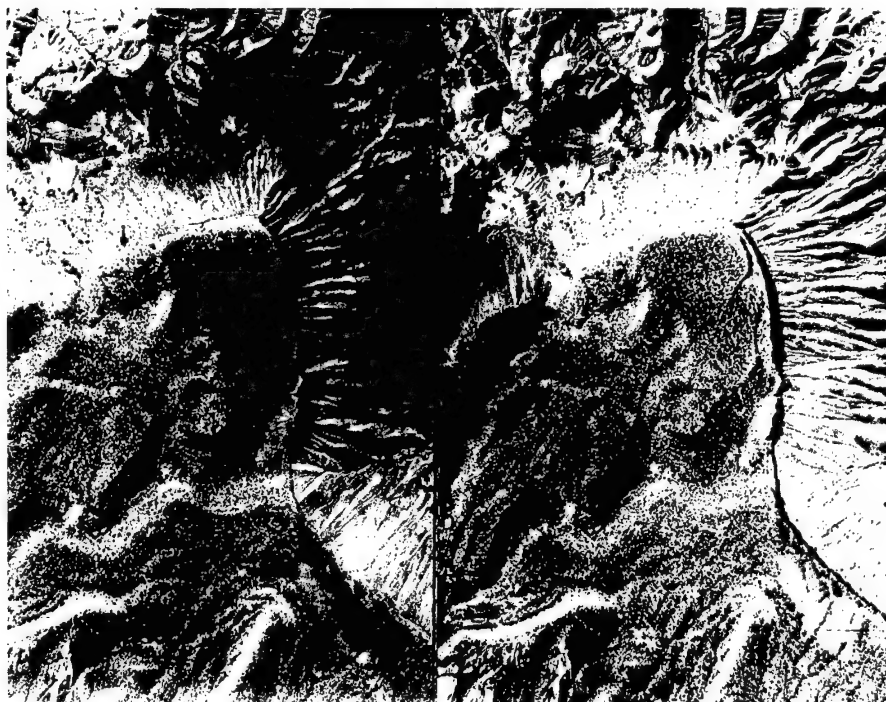
FIGURE 45.—*Tilted Sandstone and Shale.* This photo shows tilted, thick shale strata capped with sandstone in a region of 10 to 15 inches of rainfall (Mesa County, Colo.).

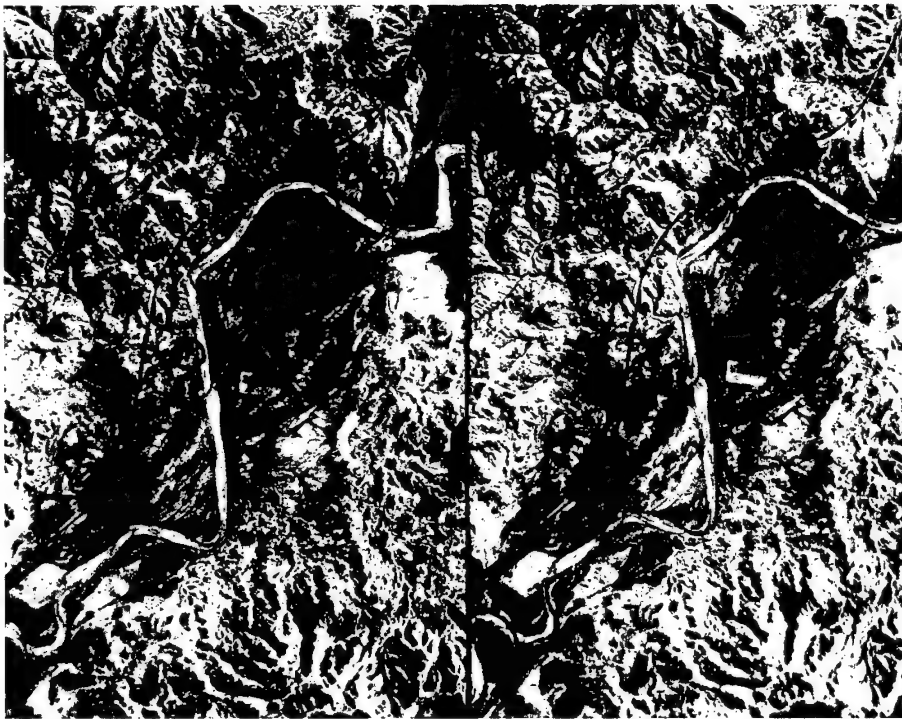
FIGURE 49. *Badlands Formed by Erosion in Shale (Lebo) near Glendive, Mont.* Very little of the original upland plain surface is left. Most of the area has been reduced by erosion forming colorful badlands. Figures 50 and 51 illustrate topography of this land form, and figure 52 illustrates performance of flexible pavements built on this shale. The chief structure at this location is clay shale which weathers to produce soft-rounded land forms. Thin layers of sandy shales and weak sandstone tend to preserve the hills, producing a more rugged topographic appearance.

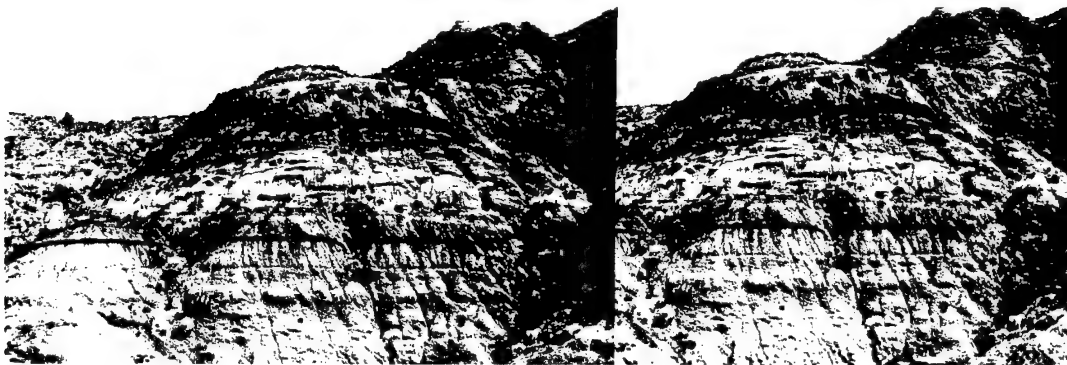
FIGURE 51.—*Broken Land Form of Shale with Sandstone.* This stereopair was taken at location 2 in figure 49 and shows a detailed view of sandy and clay shales and associated weathering of the shale member (Lebo). Note the many changes in shape and slope as layers of varying resistivity are crossed by erosional scars. This causes a broken land form.

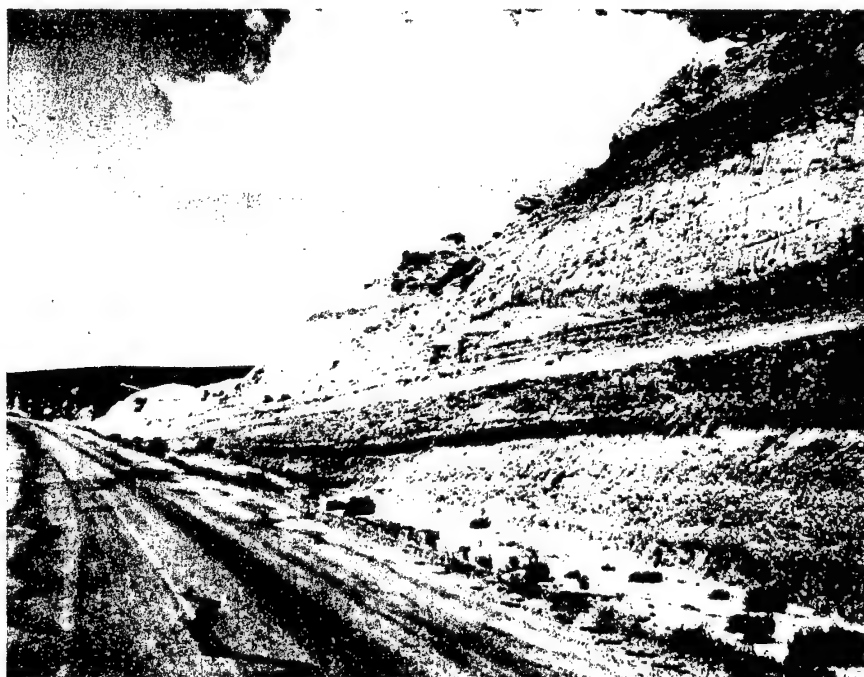
FIGURE 52.—*Highway Cut in Shale.* The numerous patches in the flexible pavement illustrate the engineering characteristics of this material. (See location 3 in fig. 49.)

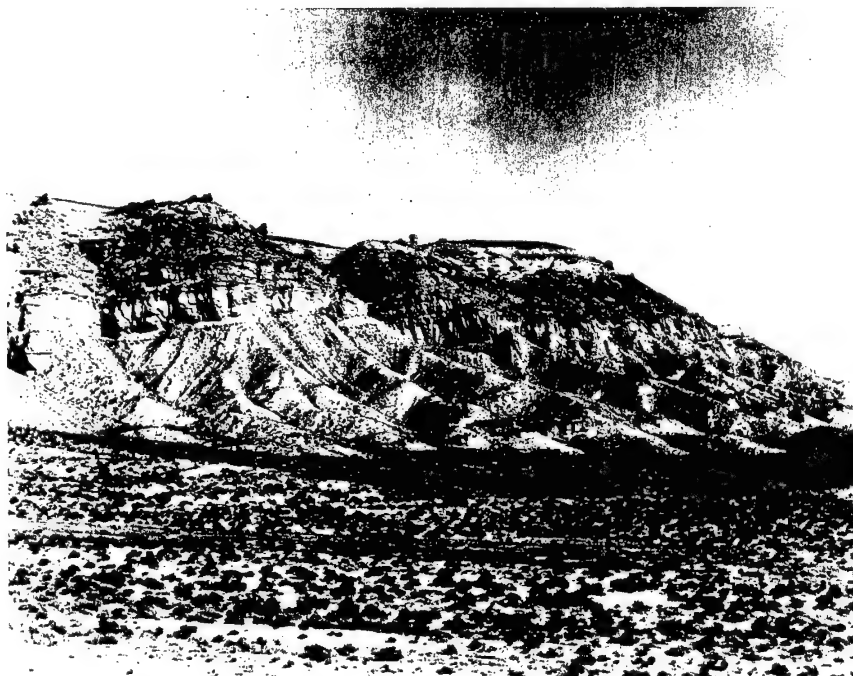
FIGURE 62.—*Shale (Cody) Capped with Sandstone and Shale (Mesa Verde).* This is 6 miles east of Rock Springs, Wyo. Note the difference in the erosion on sandstone and on the shale. This difference is one of the outstanding features used to separate the two types of rock when viewed in matched pairs of airphotos.
